Objective:

The purpose of this test was to record and document a pottery kiln glaze firing run in order to better understand how long it actually takes to reach the proper temperature and how long it remains there. This information can be used to produce better quality pottery in the future.

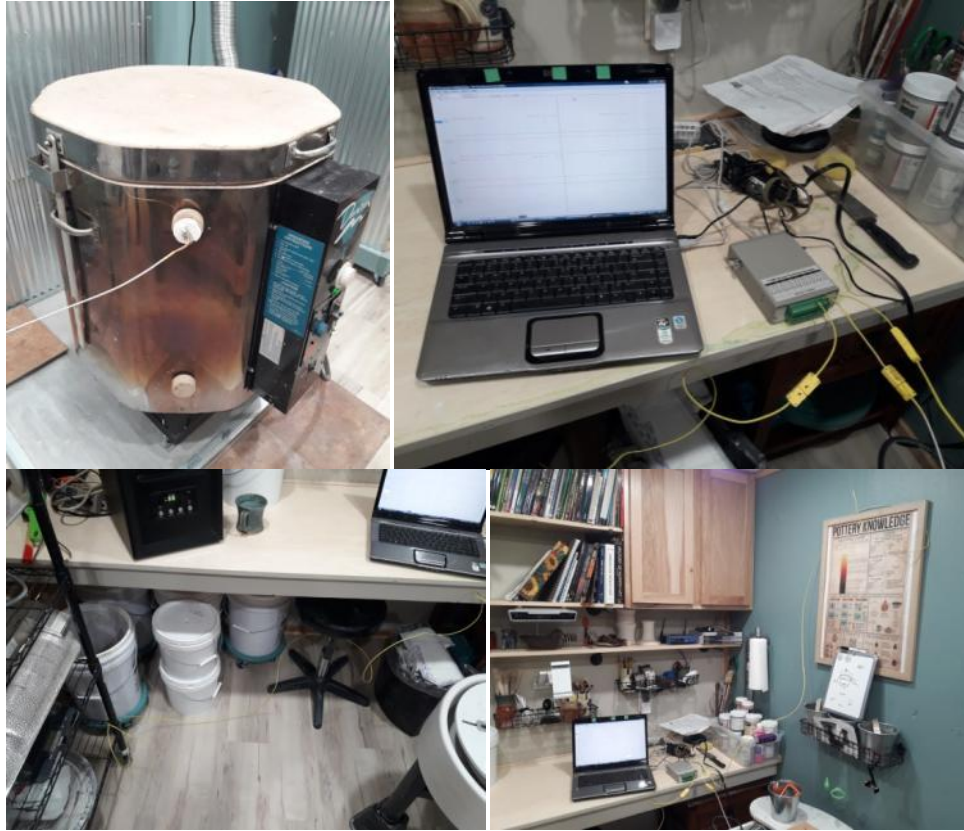
- The kiln was loaded with pottery to be glazed, and a warm-up sequence was started in which the kiln was turned on to begin heating, but the lid was propped open slightly to slow down the process.
- After two hours of warm-up, the lid was closed and the glazing cycle was allowed to resume as normal.

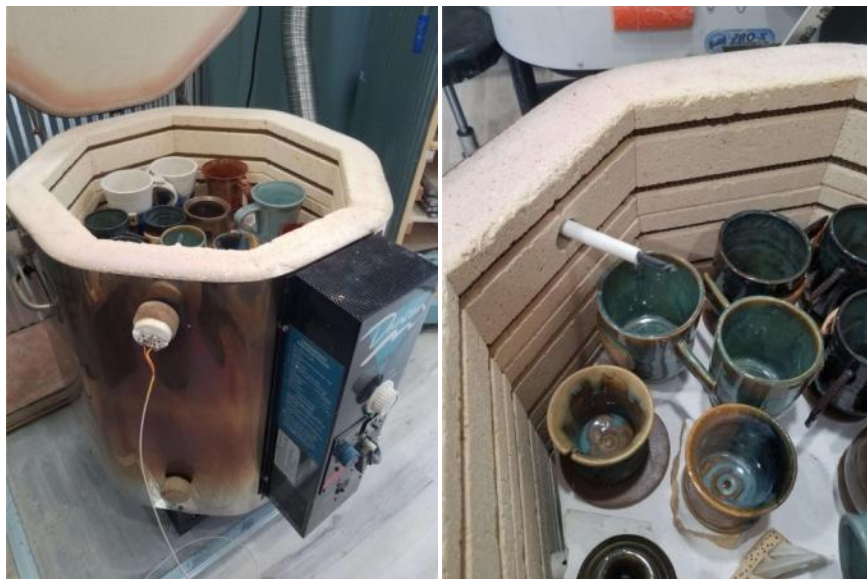
- The data recording shows that it took approximately 13.5 hours for the kiln to reach its maximum temperature after the warm-up period, at which point the kiln sitter tripped and stopped the heating process. The picture below is an example of a non-sagged kiln sitter.
